**COMMEMORATIVE AIR FORCE  
AIRCRAFT ACCIDENT  
HISTORY  
2006 THRU 2015**

*A Supplement to the 2005 Summary*

**JUNE 2016**

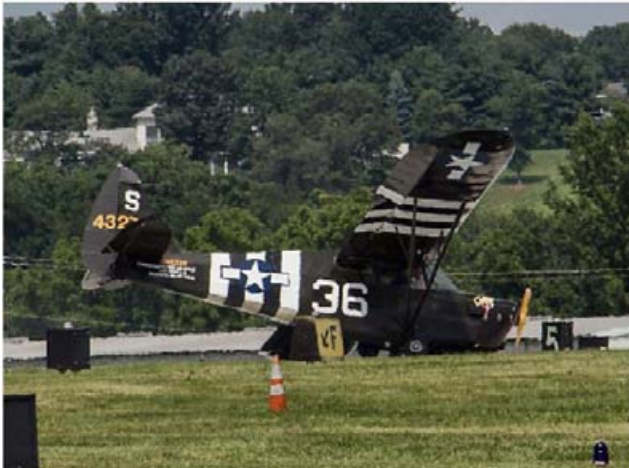
47. **August 17, 2013 in Lititz, PA:** [L-6](#)  
**PILOT IN COMMAND - failure to control the airplane's pitch attitude**  
**Contributing Factors: pilot's failure to set the trim for takeoff and wake turbulence from a preceding airplane**

The airplane departed as the fifth airplane in a formation of six airplanes during an airshow demonstration and was about 75 feet to the trailing right of the preceding airplane during the takeoff and initial climb. The pilot reported that, about 10 feet above ground level (agl), the airplane drifted right of the runway centerline and that he then realigned the airplane with the centerline. About 35 feet agl, he encountered "severe turbulence," and the airplane banked left uncontrollably. He attempted to regain control of the airplane; however, it stalled and subsequently impacted the ground in a nose-low attitude. A left crosswind of about 3 knots existed at the time of the accident. According to Advisory Circular 90-23F, "Aircraft Wake Turbulence," "a crosswind will decrease the lateral movement of the upwind vortex."

Post-accident examination revealed that the pitch trim was set in an almost full nose-up position. The pilot likely did not comply with the before takeoff checklist and confirm that the trim setting was at 0 before takeoff. In addition, the airplane likely encountered wake turbulence from the preceding airplane. The pilot reported no mechanical malfunction or abnormality that would have precluded normal operation.

The pilot's failure to control the airplane's pitch attitude, which resulted in an aerodynamic stall during the initial takeoff climb. Contributing to the accident was the pilot's failure to set the trim in accordance with the pre-takeoff checklist and the airplane's encounter with wake turbulence from a preceding airplane.

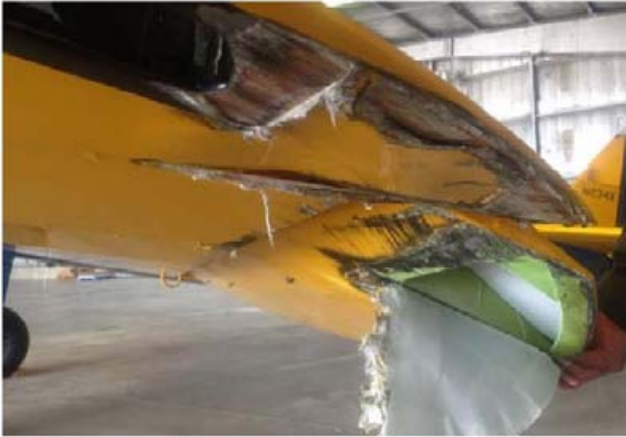
46. **August 1, 2013 in Appleton, WI:** [Stearman](#)  
**PILOT IN COMMAND - inadequate compensation for the crosswind, which resulted in a loss of directional control**

Prior to landing, the pilot listened to the automated weather station which reported the wind out of the west at 8 knots; the pilot would land on runway 21 for a normal crosswind landing. During the landing roll, the right wing lifted suddenly, the left wing contacted the ground, and the airplane ground looped. The pilot then asked the air traffic controller what the wind was, the air traffic controller responded that the wind was at 14 knots, gusting to 19 and getting stronger. Examination of the

airplane revealed substantial damage to the left wing.

The National Transportation Safety Board determines the probable cause(s) of this accident as follows:  
The pilot's inadequate compensation for the crosswind, which resulted in a loss of directional control.

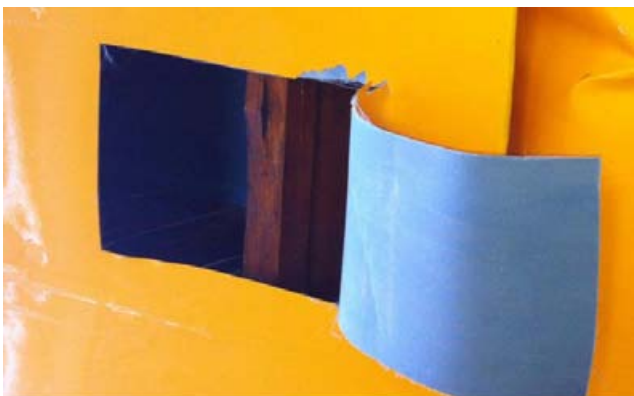
**45. March 19, 2013 in Mesa, AZ: [Stearman](#)  
PILOT IN COMMAND - failure to maintain directional control during the landing roll**

The pilot reported that as the tailwheel-equipped airplane decelerated after touchdown, it tracked left of the runway centerline. He applied corrective control inputs; however, the airplane continued to track left and departed the runway. The right wing contacted the ground and was substantially damaged during the runway excursion. The pilot reported that during the recently completed 100-hour annual inspection, the tailwheel suspension strut was modified with a different type of strut and that the new strut did not compress on landing until after right rudder was applied. However, review of the tailwheel strut design revealed that the strut only affects the vertical movement of the tailwheel, and has no lateral control effects. Post-accident examination of the airplane revealed no evidence of a mechanical failure or malfunction that would have precluded normal operation.

The National Transportation Safety Board determines the probable cause(s) of this accident as follows:  
The pilot's failure to maintain directional control during the landing roll.

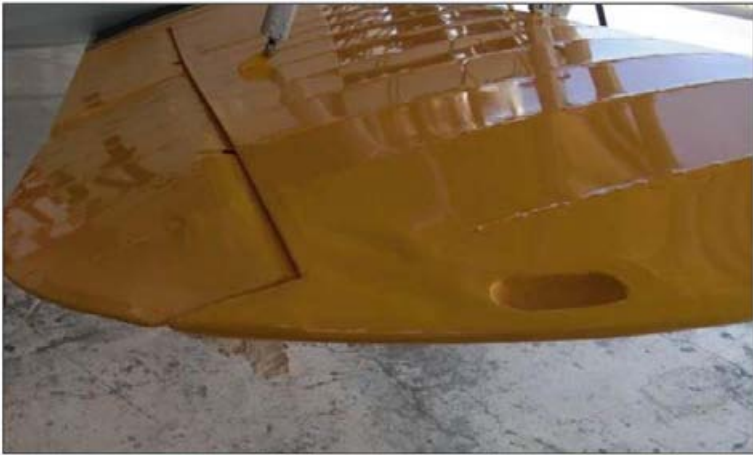
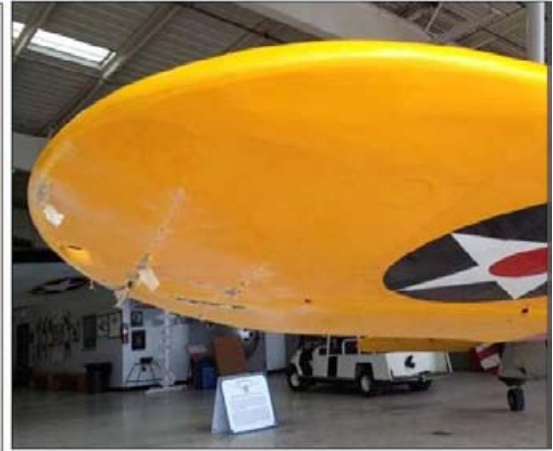
**44. August 18, 2012 in Mesa, AZ: [Stearman](#)  
PILOT IN COMMAND - failure to maintain directional control during landing**

The pilot reported that the purpose of the flight was to practice landings in the tailwheel-equipped airplane. The pilot said that during the landing roll the airplane veered left. He applied corrective control inputs in an effort to realign the airplane with the runway; however, the airplane continued left and exited the runway surface. During the accident sequence, the airplane's right wing contacted the ground, which resulted in substantial damage to the outboard section of the lower wing. The pilot reported that he was landing with a left quartering crosswind and that the airplane sustained no mechanical malfunctions or failures that would have precluded normal operation.

The National Transportation Safety Board determines the probable cause(s) of this accident as follows:  
The pilot's failure to maintain directional control while landing in a crosswind.

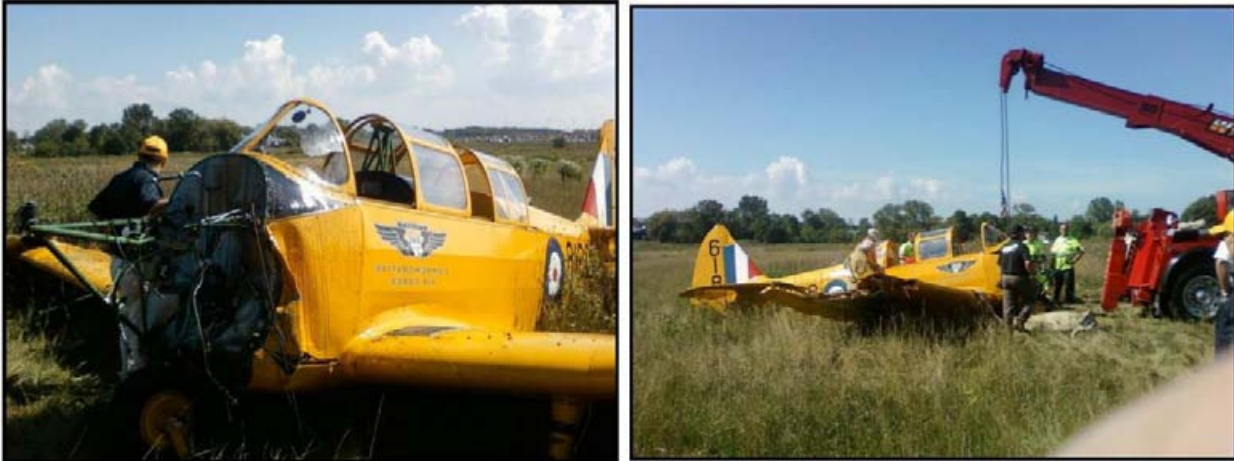
**43. September 10, 2011 in Waukegan, IL: [PT-26](#)  
PILOT IN COMMAND - inadequate preflight inspection of the airplane, which resulted in fuel exhaustion  
Contributing factors were a malfunctioning fuel gauge and air traffic**

Before flight, the pilot checked the airplane's fuel quantity using the fuel gauges but did not perform a visual inspection of the fuel tanks or top off the fuel tanks. The pilot selected the right fuel tank because its gauge indicated that it was 3/4 full. During the flight, the airplane experienced a total loss of engine power while on the downwind to base leg of the traffic pattern. The pilot turned toward the runway but realized that there was another airplane on short final that precluded his landing on the runway, so he elected to perform an off-airport landing to a field. Examination of the airplane revealed that there was no usable fuel aboard the airplane, the right fuel gauge indicated 3/4 full, and the left fuel gauge indicated empty. Federal Aviation Administration safety guidance information states that fuel gauges are subject to malfunctions and errors, and certification regulations only require that a fuel gauge read "zero" during level flight when the quantity of fuel remaining in the tank is equal to the unusable fuel supply. Therefore, fuel gauges should not be depended upon for checking the fuel quantity in a tank, and pilots should either top off fuel tanks or perform a visual inspection of fuel tanks to verify fuel

The pilot's inadequate preflight inspection of the airplane, which resulted in fuel exhaustion and a total loss of engine power. Contributing to the accident were a malfunctioning fuel gauge and air traffic that prevented an on airport landing.

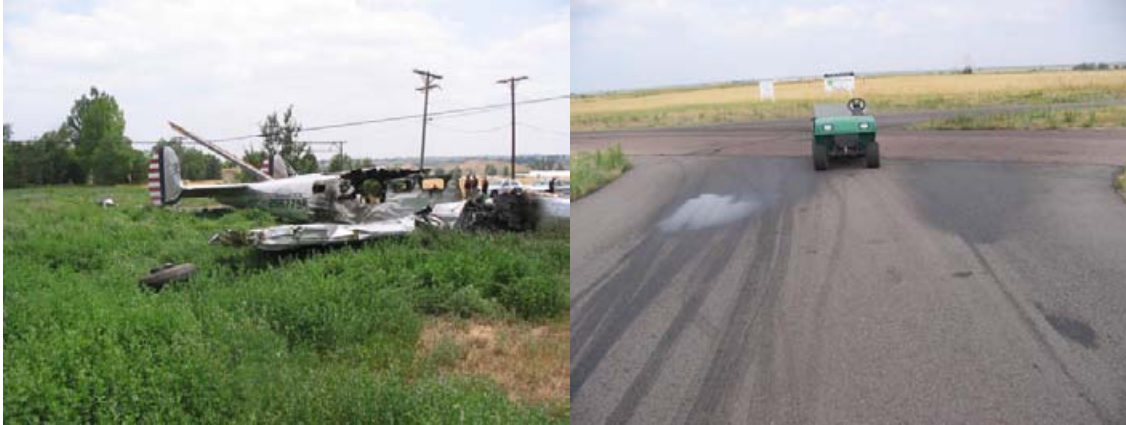
**42. July 19, 2007 near Longmont, CO: C-45H  
PILOT IN COMMAND (IP) - failure to perform proper pre-flight  
A contributing factor was the trees**

During the instructional flight, the instructor shut down the right engine and feathered the propeller. It was subsequently restarted, but the left engine started running rough and began to vibrate. The left engine was shut down and the propeller feathered. Level flight was maintained from power produced by the right engine. The left engine was then restarted but instead of producing thrust, the engine produced more drag so it was secured again. Then the right engine began losing power. Full power was applied but the airplane continued to descend. The instructor lowered the landing gear and while in-transit, the airplane clipped the tops of trees. He was able to guide the airplane between two houses and impacted an open field. The airplane bounced across the road, struck a power pole, and caught fire. The two pilots evacuated the airplane via the main cabin door. Examination at the airport of departure disclosed two pools of oil at the approximate positions of the two engines. There were two trails of oil leading from the parking spot down the taxiway and onto the runway. Both engines were partially disassembled and examined. There was evidence that both engines had failed catastrophically due to oil starvation. The left engine crankshaft was broken and all the piston heads were at the tops of their cylinders. Pieces of metal were recovered from the right engine oil sump. According to the operator, the engine rocker box recovery system must be drained during preflight to avoid hydraulic lock. The instructor stated that when they preflighted the airplane, the drain valves were open (the drained oil is captured and recycled). He thought they had closed both valves. According to the operator, either the pilot's failed to close the drain valves or they were jammed in the open position. The operator said the latter was unlikely "because you can feel it move when you close it."

The instructor pilot's improper preflight in that he failed to close the rocker box recovery system drain valves, resulting in a total loss of lubricating oil and subsequent oil starvation to both engines. A contributing factor was the trees.

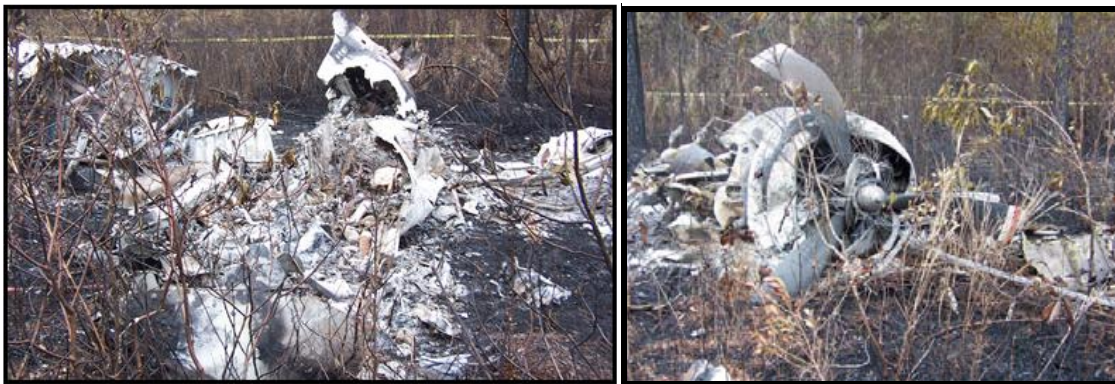
41. **May 3, 2007 near Cherry Point, NC: S-2B**  
**FLIGHT CREW - failure to comply with the published emergency procedure**  
**A contributing factor was the failure of right engine magneto**

The retired military airplane was on an approximate 3-mile final approach to the runway when it experienced a loss of power in the right engine. The crew chief entered the cockpit and pushed the power levers forward when the pilot flying (PF) called for full power. The flight crew did not comply with the memory items, nor did they comply with the "challenge and reply items" on the airplane's checklist, but instead, the pilot not flying (PNF) feathered the propeller on the left (operating) engine based solely on the PF's comment that he was holding right rudder. When the PNF perceived the left engine slowing down, but no reduction in drag, he un-feathered the left propeller. During the subsequent descent, the airplane struck power lines, trees, terrain, and was destroyed in a post-crash fire ignited by the downed power lines. Examination of the wreckage revealed heavy gauge wire wrapped around the left propeller, with signatures consistent with operation at impact. Examination of the right engine revealed a seized, inoperative dual magneto.

The flight crew's failure to comply with the published emergency procedure following a loss of engine power on the right engine. Contributing to the accident was the failure of a magneto in the right engine.

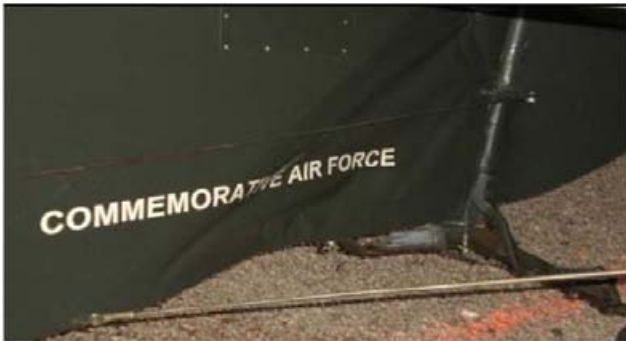
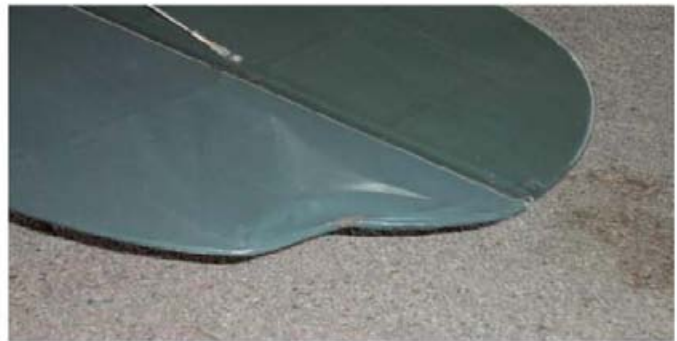
40. **October 12, 2006 in Fredericksburg, TX: L-3**  
**PILOT IN COMMAND - failure to compensate for the existing wind conditions**  
**A contributing factor was the prevailing crosswinds**

The 1,019-hour private pilot lost control of the tailwheel-equipped airplane after encountering a wind shift while landing on runway 14. The pilot reported that after checking the automated weather service station and windsock at the arrival airport, he attempted to land the single-engine airplane with a prevailing right crosswind on the dry 5,002-foot long asphalt runway. The pilot reported holding the control inputs to correct for the crosswind and suddenly encountering a wind shift from the left. The pilot indicated in the accident report (NTSB Form 6120.1), that after the main wheels touched down, the left wing lifted and the nose of the airplane turned left into the wind. The airplane then exited the left side of the 75-foot wide runway and initiated a ground loop on the wet grass adjacent to the runway. The fuselage of the airplane sustained structural damage and the pilot and passenger were not injured. The automated weather observation station on the field reported scattered skies with 10 miles visibility, with winds from 270 degrees at 6 knots.

The pilot's failure to compensate for the existing wind conditions; a contributing factor was the prevailing crosswind.
