**39. June 24, 2005 in Abilene, TX: T-28B (T-6 ZERO)**  
**PILOT IN COMMAND - failure to clear during taxi and maintain aircraft separation**

NTSB Identification: DFW05LA175A  
14 CFR Part 91: General Aviation  
Accident occurred Friday, June 24, 2005 in Abilene, TX  
Probable Cause Approval Date: 10/27/2005  
Aircraft: North American T-28B, registration: N9060F  
Injuries: 2 Uninjured.

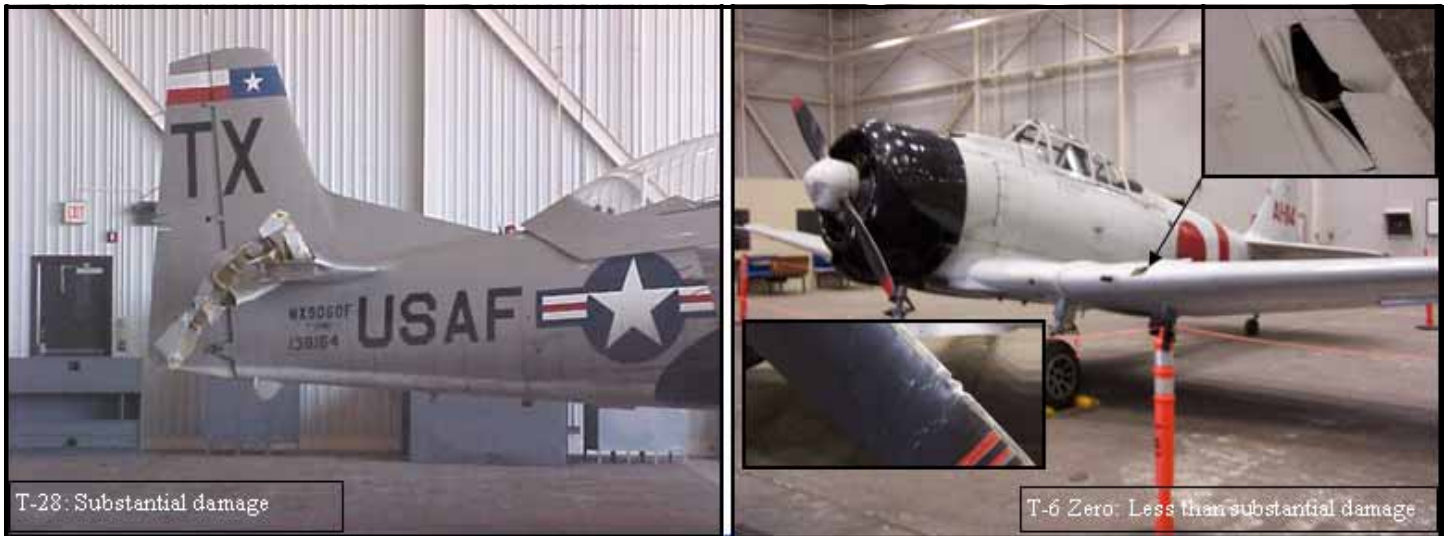
The 25,500-hour pilot was holding short of taxiway Alpha on taxiway Delta awaiting further taxi instructions when another airplane collided into the rear of his airplane. The 27,996-hour pilot of the other airplane stated that after exiting the active runway onto taxiway Delta, he switched to 119.35 megahertz (MHz), the ground control frequency depicted on his Jeppesen IFR Flight Star printout and Global Positioning System (GPS). After calling on this frequency, the pilot was notified that the correct ground control frequency was 118.35 MHz. After switching frequencies, the pilot heard an Emergency Locator Transmitter (ELT) beacon, and thinking that the signal was emitting from his airplane, the pilot attempted to reset the ELT while he continued to taxi straight ahead. Subsequently, his airplane struck the other airplane that was holding short on taxiway Delta.

The other pilot's failure to maintain clearance while taxiing. Contributing factors were the other pilot's diverted attention and the inaccurate frequency listing for ground control.

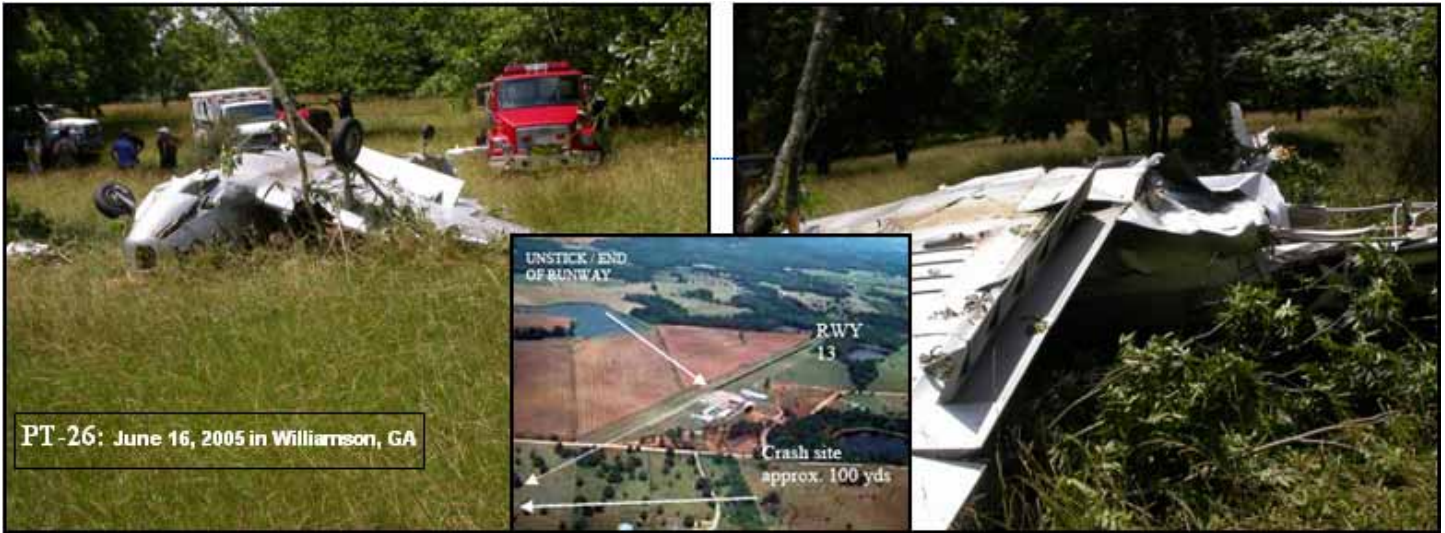
PT-26: June 16, 2005 in Williamson, GA

**38. June 16, 2005 in Williamson, GA: M-62A-3**  
**PILOT IN COMMAND - failure to follow the before takeoff checklist and attempted a takeoff with flaps extended, which resulted in an in-flight collision with trees.**

The pilot elected to takeoff up slope from the 2800 foot long runway with a 7 knot tailwind. After the airplane cleared a stand of trees on the departure end of the runway, it descended below the tree tops and collided with trees and the ground. Examination of the airplane at the accident site found the wing flaps in the full down position. According to the before takeoff checklist, wing flaps are retracted for takeoff. There were no mechanical problems discovered during the post accident examination.

The pilot's failure to follow the before takeoff checklist and attempted a takeoff with flaps extended, which resulted in an in-flight collision with trees.

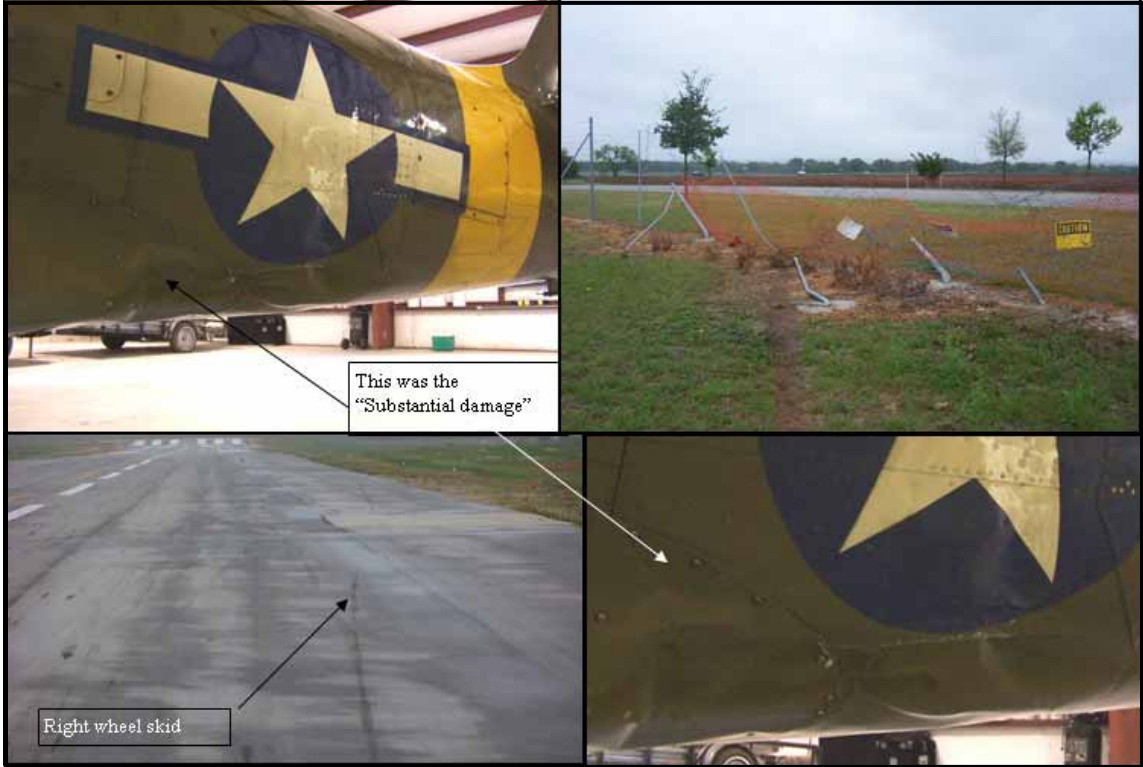
**37. April 18, 2005 in Fredericksburg, TX: P39**  
**PILOT IN COMMAND - failure to maintain directional control during the landing roll.**  
**A contributing factor was the reported partial failure of the left wheel brake.**

The 5,753-hour commercial pilot lost directional control during the landing roll, and the vintage airplane drifted off of the runway and struck a fence 200-feet beyond the departure end of the runway. During the straight-in approach to the 5,002-foot long by 75- feet wide runway, the pilot noticed that the airplane's airspeed was above the flap extension speed of 140 mph, and "elected to continue with a no-flap landing." A witness at the airport ramp reported that the airplane "appeared to be at an excessive rate of speed" on final approach. He further reported that the observed the nose wheel touched the runway prior to the main wheels. The pilot added that as he applied brakes after landing, the left brake "was not responding normally." Examination of the airplane brake system by the operator did not reveal any anomalies.

The pilot's failure to maintain directional control during the landing roll. A contributing factor was the reported partial failure of the left wheel brake.

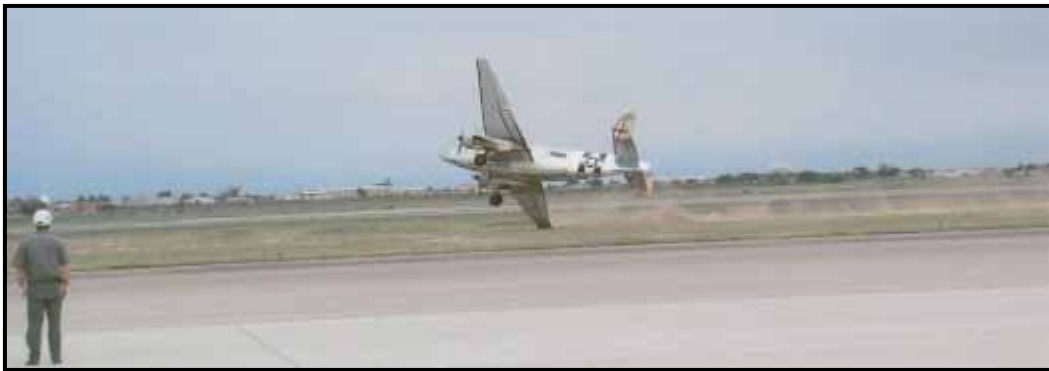
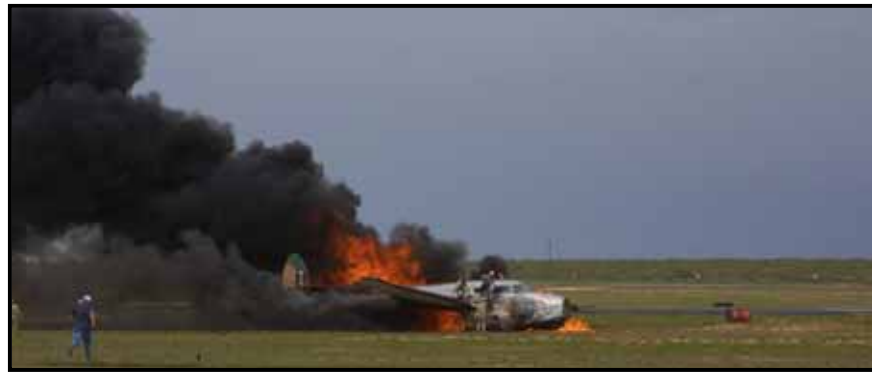
**36. October 03, 2004 in Midland, TX: Lockheed 18-56**  
**PILOT IN COMMAND - failure to maintain directional control during takeoff**  
Contributing factors were the choice of runway used and the prevailing tailwind.

The 18,000- hour pilot was cleared for takeoff in the vintage twin-engine tail wheel equipped airplane on a 9,501- foot by 50- foot runway. The pilot was aware that there was a tailwind from approximately 160 degrees at 10 knots. Shortly after starting the takeoff roll, the airplane swerved to the right. The pilot was able to correct back to the centerline utilizing rudder control. The airplane then swerved to the left, and full right rudder was applied but the swerve could not be corrected. By the time the airplane reached the left edge of the runway, the airplane had not reached its calculated V2 speed of 110 knots. The airplane departed the left side of the runway, went airborne and shortly thereafter, the right wing dropped and contacted the ground. The airplane then spun 180 degrees, impacted the ground, slid backward, and came to rest upright. A post-crash fire consumed the aft fuselage and left wing.

The pilot's failure to maintain directional control during takeoff. Contributing factors were the choice of runway used and the prevailing tailwind.

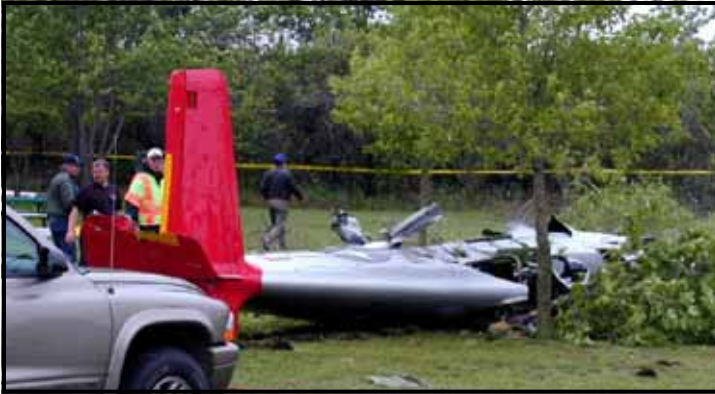
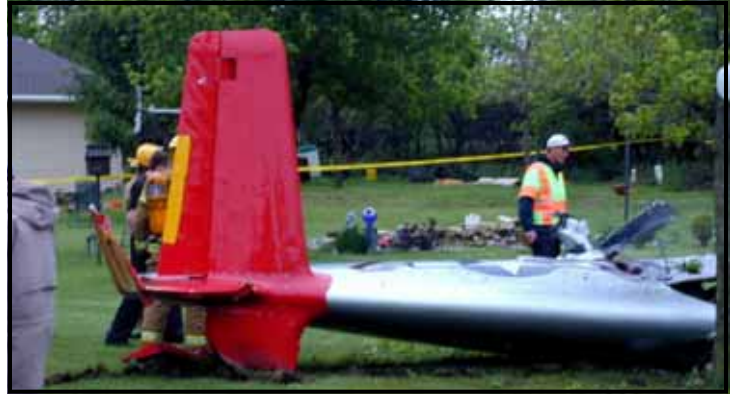
**35. May 29, 2004 in Hager City, WI: P-51C**

**The improper installation of the camshaft drive gear assembly which resulted in the retaining nut backing off allowing the drive gear to move up the shaft.**

The improper installation of the camshaft drive gear assembly which resulted in the retaining nut backing off allowing the drive gear to move up the shaft. A factor associated with the accident was the low altitude at which the power loss occurred and the trees which the airplane contacted during the forced landing.

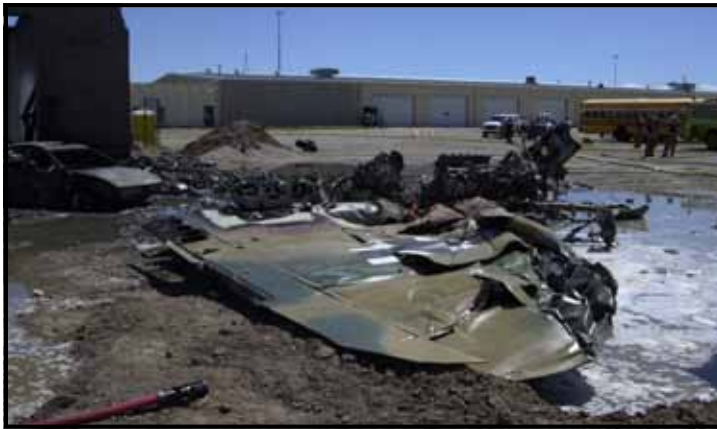
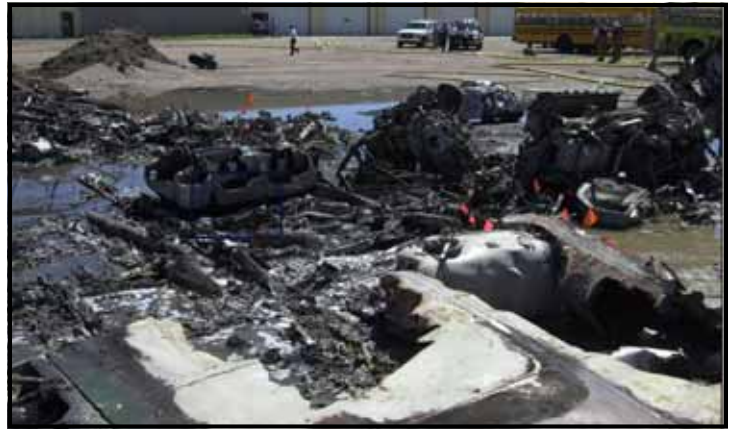
**33. July 10, 2003 in Cheyenne, WY: [CASA 2.111](#)  
**Loss of engine power for reasons undetermined**  
**PILOT IN COMMAND - failure to maintain aircraft control.****

The airplane was en route to an air show and was making a refueling stop. The tower controller cleared the pilot to land. The airplane was observed on a 3-mile straight-in final approach when it began a left turn. The controller asked the pilot what his intentions were. The pilot replied, "We just lost our left engine." The pilot then reported that he wasn't going to make it to the airport. Witnesses observed the airplane flying "low to the ground and under-speed for [a] good 4 minutes." The right propeller was turning, but the left propeller was not turning. There was no fire or smoke coming from the left engine. The pilot was "obviously trying to pull up." The airplane "dipped hard left," then struck the ground left wing first. It slid through a chain link fence, struck a parked automobile, and collided with a school bus wash barn. The ensuing fire destroyed the airplane, parked car, and wash barn. Disassembly and examination of both engines disclosed no anomalies that would have been causal or contributory to the accident. According to the Airplane Flight Manual, "Maximum power will probably be required to maintain flight with one engine inoperative. Maximum power at slow air speed may cause loss of directional control."

A loss of engine power for reasons undetermined, and the pilot's failure to maintain aircraft control. Contributing factors were the unsuitable terrain on which to make a forced landing, low airspeed, the fence, automobile, and the school bus wash barn.

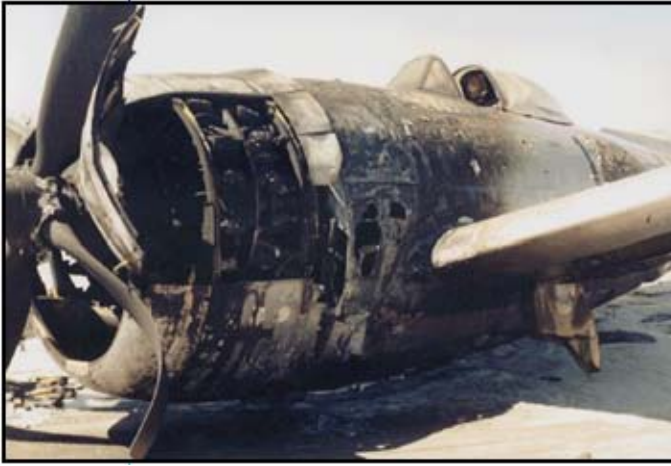
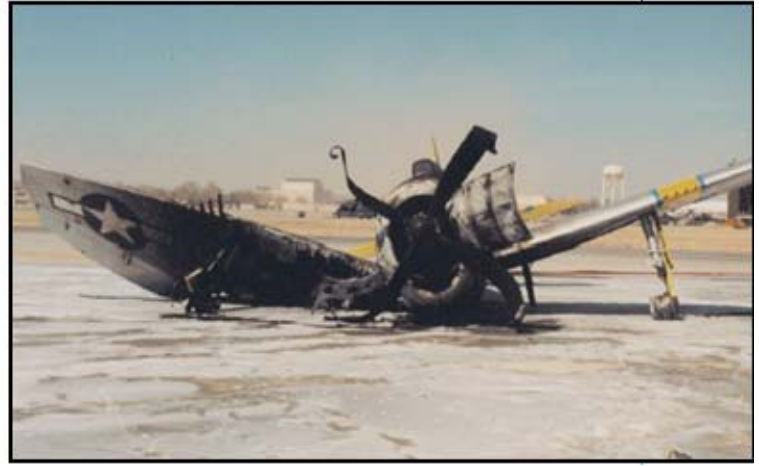
**32. March 21, 2002 in Albuquerque, NM: [P-47N-20-RE](#)  
**Pilot/mechanic's failure to properly re-install the engine's #10 cylinder exhaust interconnect tube, which resulted in an in-flight fire and forced landing****

According to the pilot, who was an FAA certified airframe and power plant mechanic, on the morning the accident, he completed re-installing the engine following its overhaul by another company. He made several engine run and leak checks, and all parameters were within limits and no leaks were noted. He then boarded the airplane for a 15 minute maintenance test flight. The flight taxied to the runway, and the pilot performed a pre-takeoff engine run-up, noted no anomalies and departed. During the initial takeoff climb, just as the pilot reached for the landing gear lever, the cockpit filled with black smoke, and the engine began to lose power. The tower controller then reported to the pilot that the airplane was on fire. The pilot executed a forced landing back to the runway, which had some length remaining. The airplane impacted the ground, and an intense fire erupted (the pilot observed a flash fire through the cockpit). The airplane slid 1,000 feet and came to rest upright. Examination of the airplane revealed that the exhaust interconnect tube to the exhaust collector for the #10 cylinder was protruding through the inlet duct of the lower cheek cowl, and was disconnected from the cylinder. The area around the opening exhibited severe heat distress, consistent with a fire. Oil supply lines and the main fuel supply line were melted through and compromised. The oil and fuel line hoses were made of rubber and were not outfitted with fire shields. No other pertinent anomalies were discovered with the #10 cylinder or the remainder of the engine.

the pilot/mechanic's failure to properly re-install the engine's #10 cylinder exhaust interconnects tube, which resulted in an in-flight fire and forced landing. Contributing factors were the burned fuel and oil supply lines, which were not fire shielded.

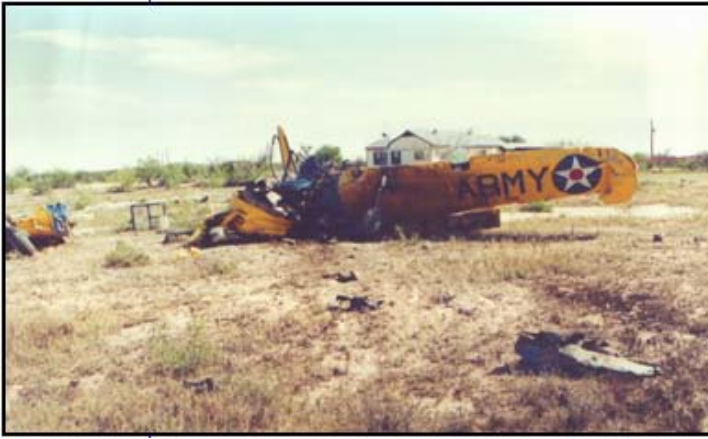
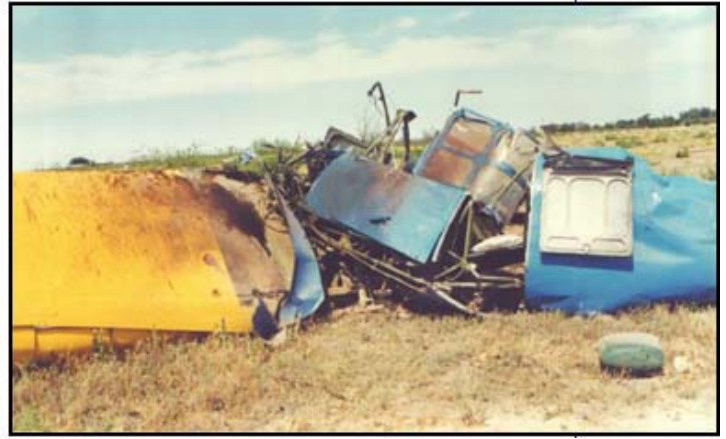
**PILOT IN COMMAND - failure to maintain the minimum required airspeed for flight, which resulted in a loss of control while performing a go-around**

the pilot's failure to maintain the minimum required airspeed for flight, which resulted in a loss of control while performing a go-around. A contributing factor to the accident was the gusty tailwind condition.

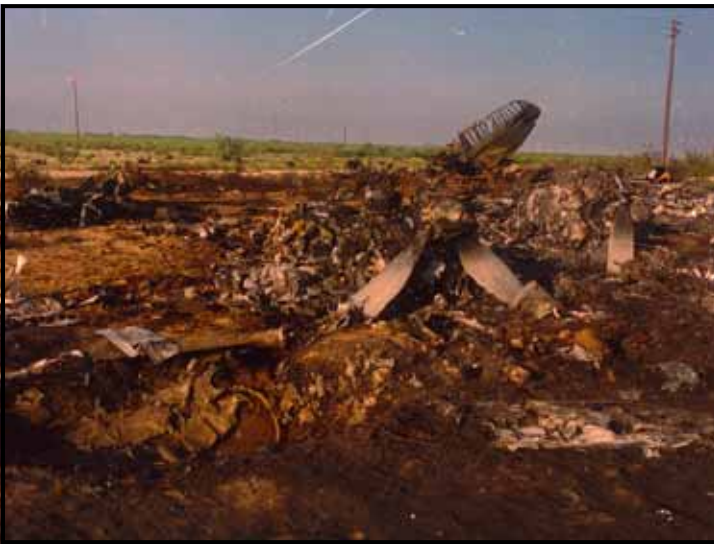
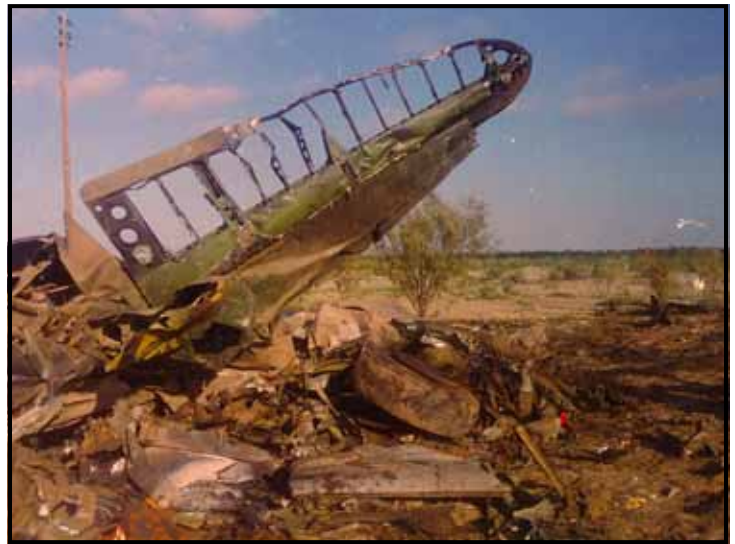
27. September 28, 1995 in ODESSA, TX: **B-26C**

Witnesses observed the aircraft approximately 250 feet above the ground heading towards the southwest. As the aircraft passed overhead, the 'engines were sputtering.' Approximately 3/4 mile from the witnesses, the aircraft made a 'sharp' right turn, nosed down, and impacted the ground. The engines 'quit' prior to the aircraft turning right. According to the operator, the flight was in preparation for a flight evaluation for the pilot-in-command by an FAA inspector. The pilot reported to Departure Control that he would be 'working on stalls and steep turns,' and the pilot was instructed to 'maintain VFR at or above five thousand five hundred.' The pilot-in-command had accumulated approximately 500 hours in the B-26. Prior to the accident flight, he had flown the B-26 once since October 8, 1993. That flight was on September 26, 1995, for a duration of 30 minutes. Prior to the flight the fuel tanks were 'sticked' and the total fuel was approximately 720 gallons of 100 octane low lead avgas. Examination of the airplane and engines did not disclose any preflight discrepancies. Due to the extent of damage, flight control continuity could not be established.

the failure of the pilot to maintain minimum airspeed for flight resulting in an inadvertent stall/spin. Factors were the loss of power for undetermined reasons, and the pilot's lack of recent flight experience in the aircraft.

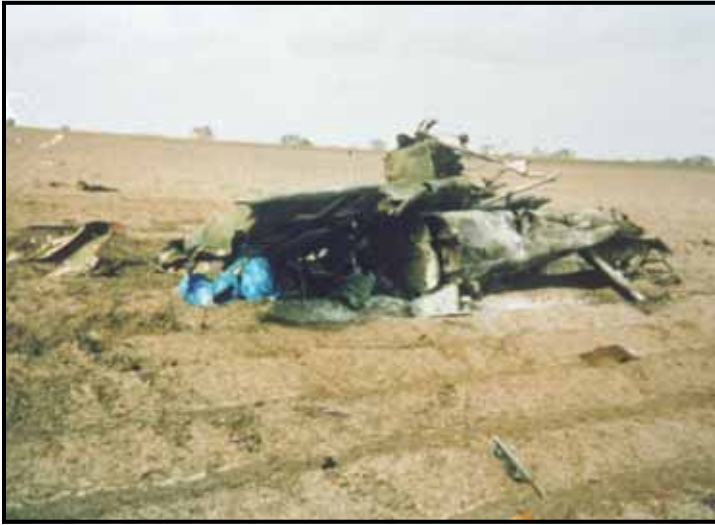
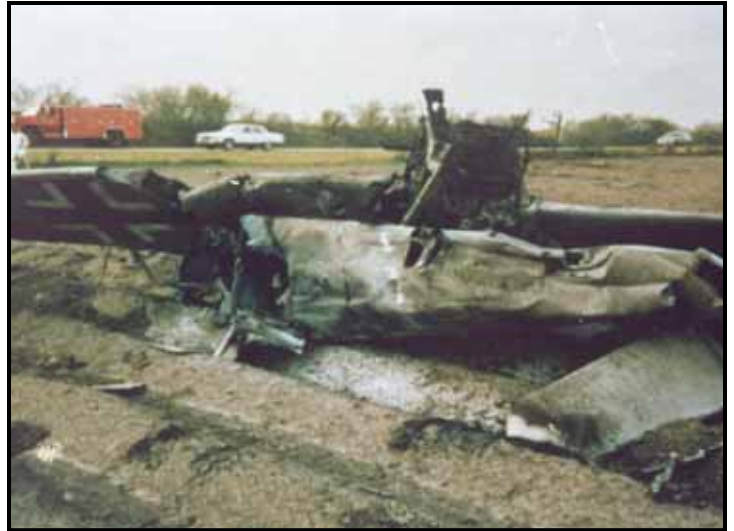
**20. December 19, 1987 in HARLINGEN, TX: *MBB 109*  
FUEL SYSTEM, CARBURETOR FLOAT - DETERIORATED/ MOVEMENT RESTRICTED  
PILOT IN COMMAND - AIRSPEED (VS) NOT MAINTAINED**

THE SET OF FLOATS WHICH ALLOWS A HIGH FUEL FLOW IN THIS CARBURETOR FOR HIGH POWER SETTINGS USED FOR TAKEOFF, CLIMB, ETC., HAD CRACKED AND SWOLLEN TO SUCH AN EXTENT THAT THEY WERE RUBBING AGAINST THE FLOAT CHAMBER WALLS AND FLOAT CHAMBER SHROUD TUBES. THIS INTERFERENCE PREVENTED ADEQUATE FUEL FLOW FOR HIGH POWER OPERATION OF THE ENGINE DURING THE TAKEOFF CLIMB WHICH TERMINATED IN THE ACCIDENT. THERE WERE NO ENTRIES IN THE MAINTENANCE LOGS WHICH INDICATED ANY MAINTENANCE OR INTERNAL EXAMINATION OF THE CARBURETOR SINCE THE AIRCRAFT WAS NEW (1959).

AIRSPEED(VS)..NOT MAINTAINED..PILOT IN COMMAND  
FUEL SYSTEM,CARBURETOR FLOAT..DETERIORATED  
FUEL SYSTEM,CARBURETOR FLOAT..MOVEMENT RESTRICTED

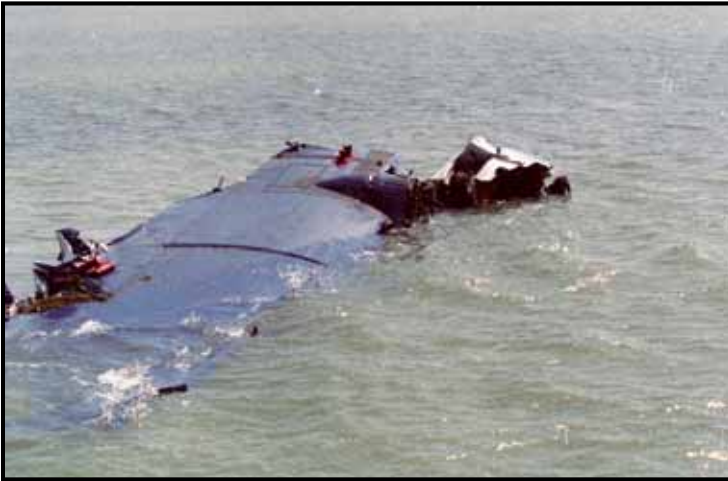
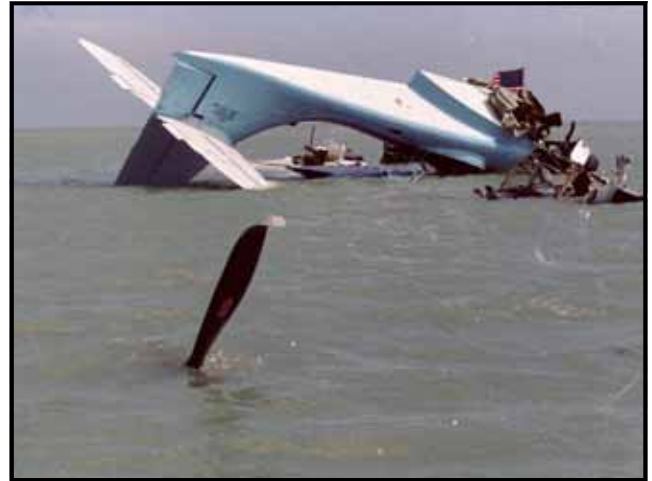
**17. October 13, 1984 in PORT ISABEL, TX: Consolidated-Vultee PBY-6A**  
**COPILOT/SECOND PILOT - CLEARANCE MISJUDGED**  
**PILOT IN COMMAND - SUPERVISION INADEQUATE**

CLEARANCE..MISJUDGED..COPILOT/SECOND PILOT;SUPERVISION..INADEQUATE..PILOT IN COMMAND,DOOR,LANDING GEAR..OVERLOAD; DOOR,LANDING GEAR..SEPARATION. Contributing Factors  
TERRAIN CONDITION..WATER,GLASSY

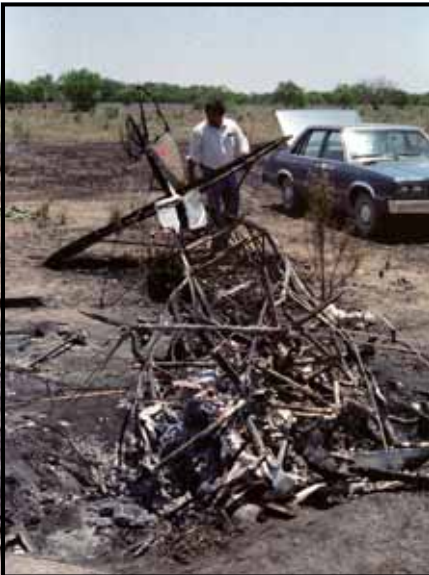
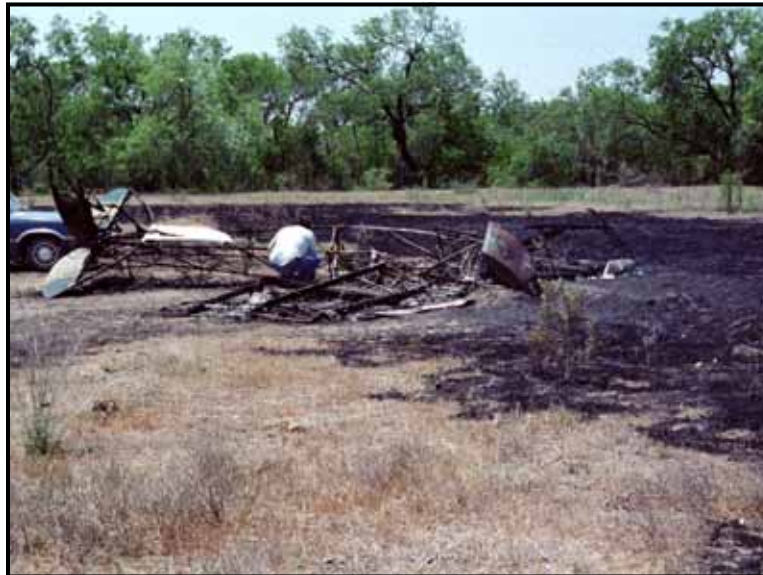
16. May 02, 1984 in SAN ANTONIO, TX: **TIGER MOTH DH 82A**  
**PILOT IN COMMAND - STALL NOT CORRECTED**  
**- ALTITUDE INADEQUATE**  
**- REASON FOR OCCURRENCE UNDETERMINED**

THE ACFT CRASHED IN AN OPEN PASTURE WITH TREES ON THE WESTERN PERIMETER. THE ACFT ATTITUDE AT IMPACT WAS NOSE DOWN AT A 30 TO 50 DEGREE ANGLE IN A RIGHT SPIRAL. THE MAIN FUEL TANK MOUNTED ON THE TOP WING OVER AND BEHIND THE ENGINE BROKE FROM ITS MOUNT ON IMPACT AND RUPTURED. A FIRE BROKE OUT AND CONSUMED THE ACFT. A 11 YR OLD BOY SAID HE SAW THE ACFT CLIMB OVER SOME TREES, MAKE A LEFT TURN AND THEN HE HEARD THE ENGINE QUIT RUNNING. THE ACFT NOSED OVER SHARPLY AND DESCENDED BELOW THE TREES. THE WITNESS THEN SAW THE FIRE BALL. PLTS WHO HAD FLOWN THE ACFT SAY IT STALLS WITHOUT WARNINGIF POWER IS RETARDED AND THE SPEED IS DISSIPATED AND THAT THE ACFT ALWAYS FELL OFF ON THE RIGHT WING DURING THE STALL.

STALL..NOT CORRECTED..PILOT IN COMMAND  
REASON FOR OCCURRENCE UNDETERMINED  
ALTITUDE..INADEQUATE..PILOT IN COMMAND
