**39. June 24, 2005 in Abilene, TX: T-28B (T-6 ZERO)**  
**PILOT IN COMMAND - failure to clear during taxi and maintain aircraft separation**

NTSB Identification: DFW05LA175A  
14 CFR Part 91: General Aviation  
Accident occurred Friday, June 24, 2005 in Abilene, TX  
Probable Cause Approval Date: 10/27/2005  
Aircraft: North American T-28B, registration: N9060F  
Injuries: 2 Uninjured.

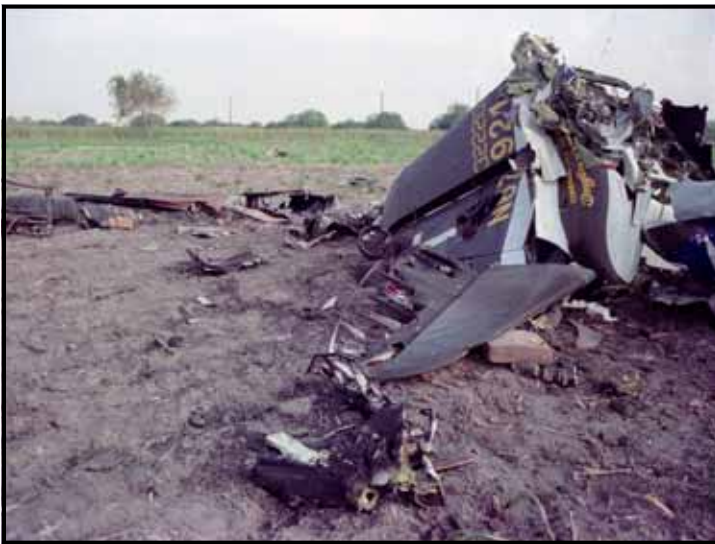
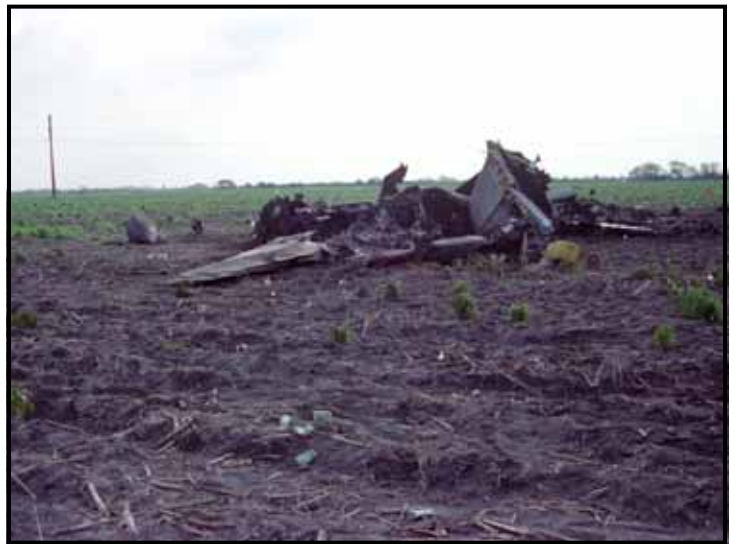
**20. December 19, 1987 in HARLINGEN, TX: *MBB 109*  
FUEL SYSTEM, CARBURETOR FLOAT - DETERIORATED/ MOVEMENT RESTRICTED  
PILOT IN COMMAND - AIRSPEED (VS) NOT MAINTAINED**

THE SET OF FLOATS WHICH ALLOWS A HIGH FUEL FLOW IN THIS CARBURETOR FOR HIGH POWER SETTINGS USED FOR TAKEOFF, CLIMB, ETC., HAD CRACKED AND SWOLLEN TO SUCH AN EXTENT THAT THEY WERE RUBBING AGAINST THE FLOAT CHAMBER WALLS AND FLOAT CHAMBER SHROUD TUBES. THIS INTERFERENCE PREVENTED ADEQUATE FUEL FLOW FOR HIGH POWER OPERATION OF THE ENGINE DURING THE TAKEOFF CLIMB WHICH TERMINATED IN THE ACCIDENT. THERE WERE NO ENTRIES IN THE MAINTENANCE LOGS WHICH INDICATED ANY MAINTENANCE OR INTERNAL EXAMINATION OF THE CARBURETOR SINCE THE AIRCRAFT WAS NEW (1959).
